BATTERY HANDLING SYSTEMS

Tech Tip # TSB06-002

Collector Trolley Alignment

Models Affected: All Battery Extractors

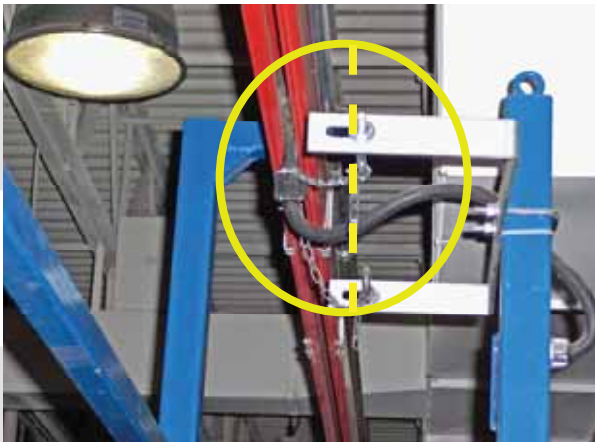
Proper alignment of the collector trolley with the buss duct is very important to prevent premature wearing of the brushes and costly replacement of the collector trolley.

IMPROPER ALIGNMENT

The collector trolley needs to be properly aligned with the buss duct at the time of installation. The collector trolley should be checked on a regular basis to ensure all hardware is properly attached and that the tow arm has not been bent.

If the tow arm has been bent replacement parts are needed to correct the damage.

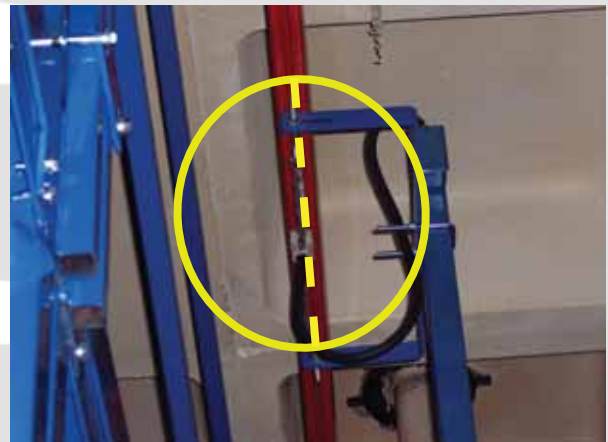
PROPER ALIGNMENT
